STANDARD CORRUGATED DETAILS

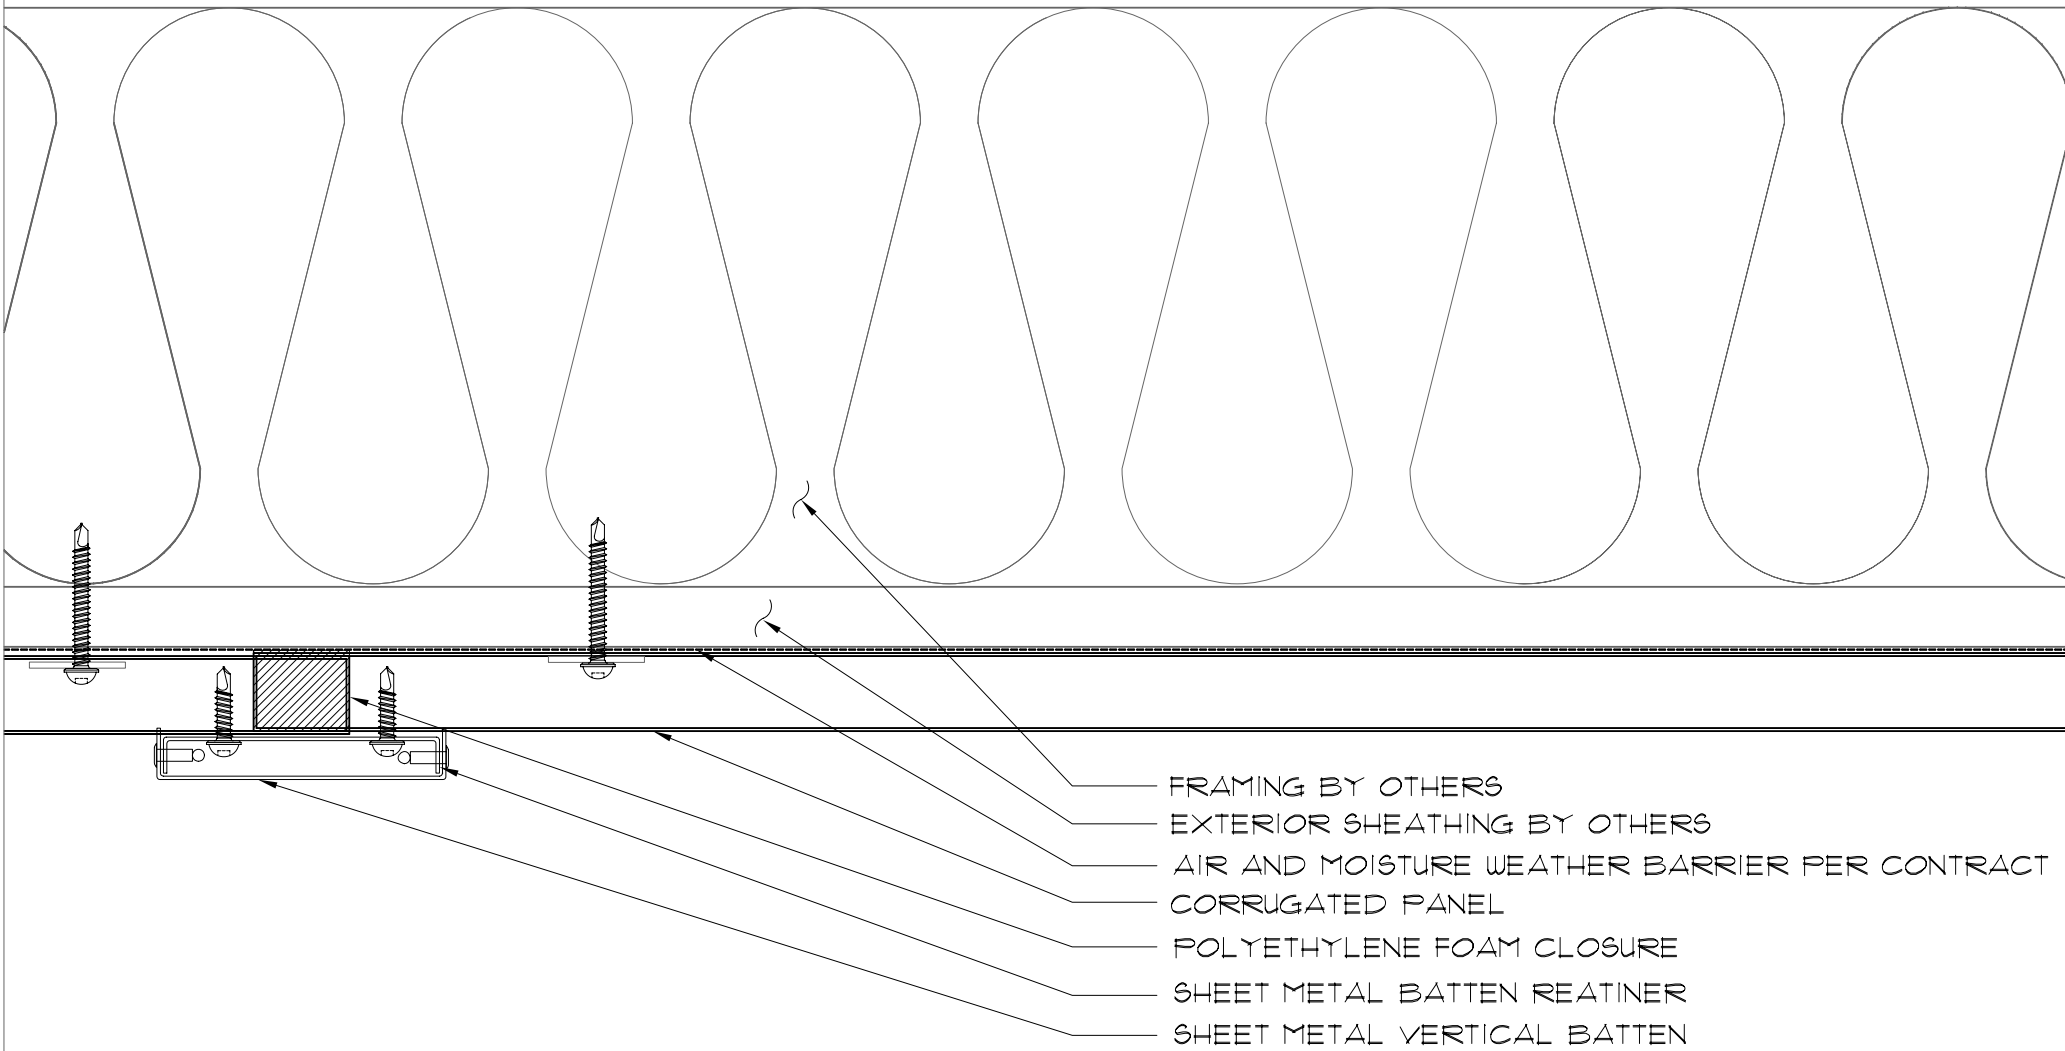
Ø1 CORRUGATED VERTICAL BATTEN DETAIL
